SPECIAL AIRWORTHINESS INFORMATION BULLETIN

No. NE-03-28
March 10, 2003

The Special Airworthiness Information Bulletin (SAIB) advises you, owners and operators of **Bombardier CL 600 Challenger CL-600-1A11 (CL-600), CL-600-2A12 (CL-601), CL-600-2B16 (CL-601-3A) & (CL-601-3R)& (CL-604)** as well as the **RJ 100 (CL 600-2B19)** series aircraft that Transport Canada (TC) has recently received a Service Difficulty Report regarding a bearing failure in the Aileron Quadrant/Feel Unit, P/N 600-91178-7, on a CL 600 2A12 (601) Challenger aircraft. TC has released Service Difficulty Alert No. AL-2003-01 dated January 9, 2003, to perform an operational check on the aileron system.

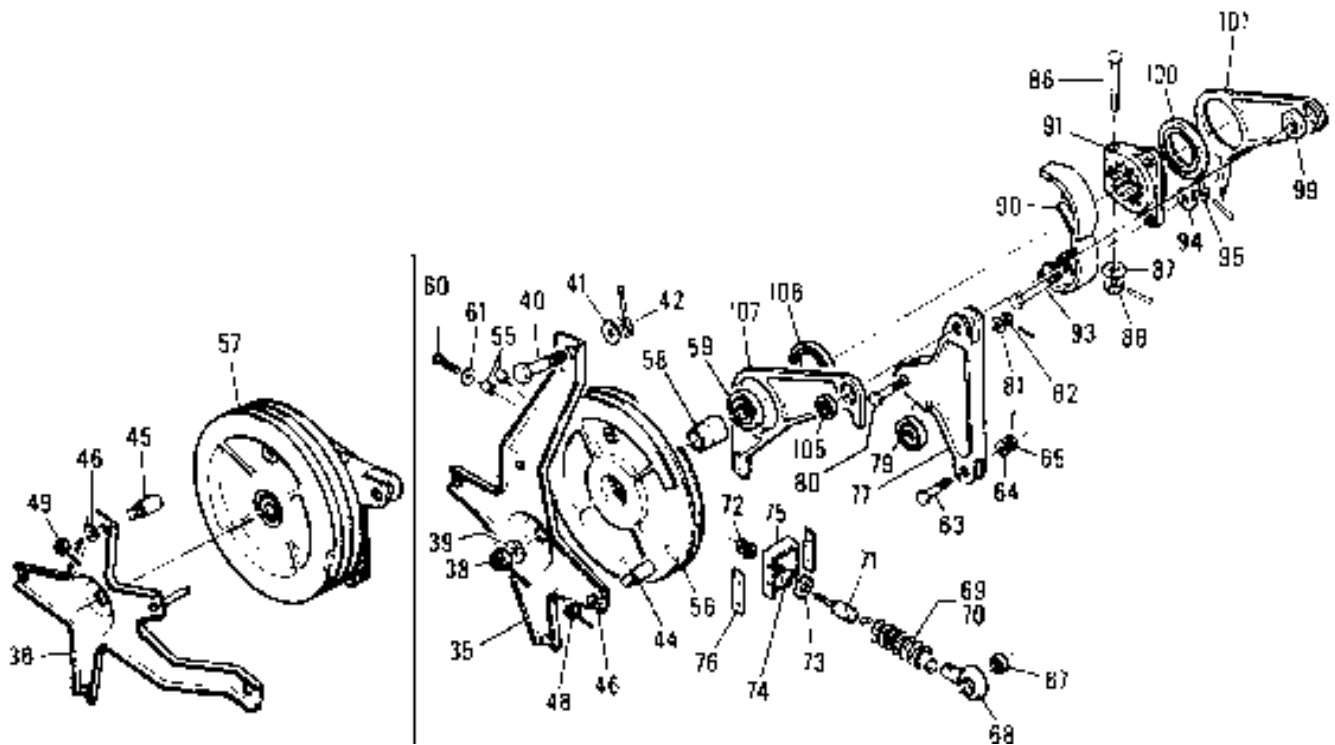
Figure 1

Maintenance personnel performed a 600-hour inspection and after completing operational tests on the aileron system, they exercised the ailerons bleeding off the hydraulic system pressure. When the pressure was released, they heard a loud bang while moving the controls. While troubleshooting and moving the aileron controls again, they heard the bang again. They determined the source of the noise was the wheel well quadrant. They removed and disassembled the quadrant. They found quadrant bearing, P/N MS 27646-39 (Item 59, figure 1 of this SAIB, Re: IPC 27-12-00, Page 3 Figure 1(D)) was dry of grease and the balls had worn a deep groove into the inner race.

It is important to note that the operator did not experience any symptoms that would have lead to the discovery of this degradation prior to its failure; example: stiff or ratcheting control wheel. This quadrant has a common part number throughout the Challenger and Regional Jet 100 fleet.

The FAA strongly recommends that you carry out an operational check on the aileron system similar to the scenario above to ensure the presence of sufficient lubrication in the subject bearing. If left undetected, aileron control operation could be compromised. You should report any defects or further occurrences to the New York Aircraft Certification Office (NYACO).
